Organic Peroxide-Formers

Lab Safety Incident UTHSC – February 2018

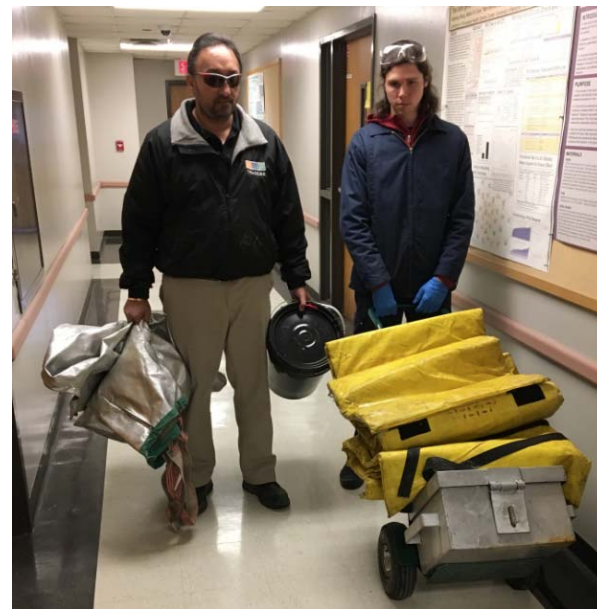
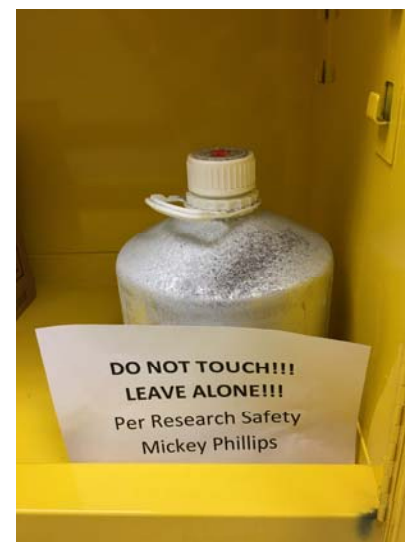
Incident: In February 2018 a container of diethyl ether of unknown age was found during a routine lab safety inspection. Crystal formations were visible on the container indicating the presence of potentially reactive organic peroxides. Following this discovery the entire Johnson Building was closed for three days and access prohibited while awaiting the arrival of a High Hazard Response Team to neutralize the potentially explosive compound. Once neutralized the container was removed from the building and disposed of as hazardous chemical waste.

Safety: The [UTHSC Chemical Hygiene Plan](#) details the institutional procedure for the storage and handling of peroxide-forming compounds (e.g. ethers, THF, dioxane, etc.). These compounds must be labeled with the date the container was received and opened. Before handling the container must be inspected for signs of crystallization, discoloration or other evidence of degradation. Containers showing signs of crystallization or degradation must remain in place and the Office of Research Safety Affairs contacted immediately. Peroxide test strips must be available in all labs where these compounds are handled and used to test the concentration of peroxides in opened containers. Any compounds with a peroxide concentration greater than 30ppm must be discarded as hazardous waste by contacting labsafety@uthsc.edu. A more complete list of peroxide-forming compounds is accessible on the [Research Safety Affairs website](#).
